# Remote Sensing Estimates of Evapotranspiration at a Southwestern Uranium Mill Tailings Site

# Shiprock, NM Uranium Mill Site

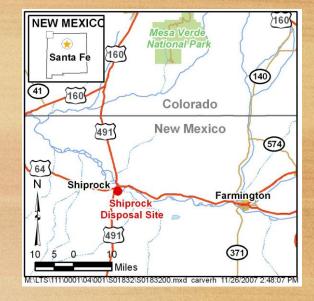
Contaminated groundwater at the Shiprock site occurs in a terrace and a floodplain of the San Juan River that are separated by an escarpment. A disposal cell for mill tailings is located on the terrace.
