Site assessments to inform restoration design and planning – A case study at Arlington Wildlife Area in Arizona

**Monisha J. Banerjee,
GeoSystems Analysis, Inc.**

AWA Restoration Design (Revision 2)

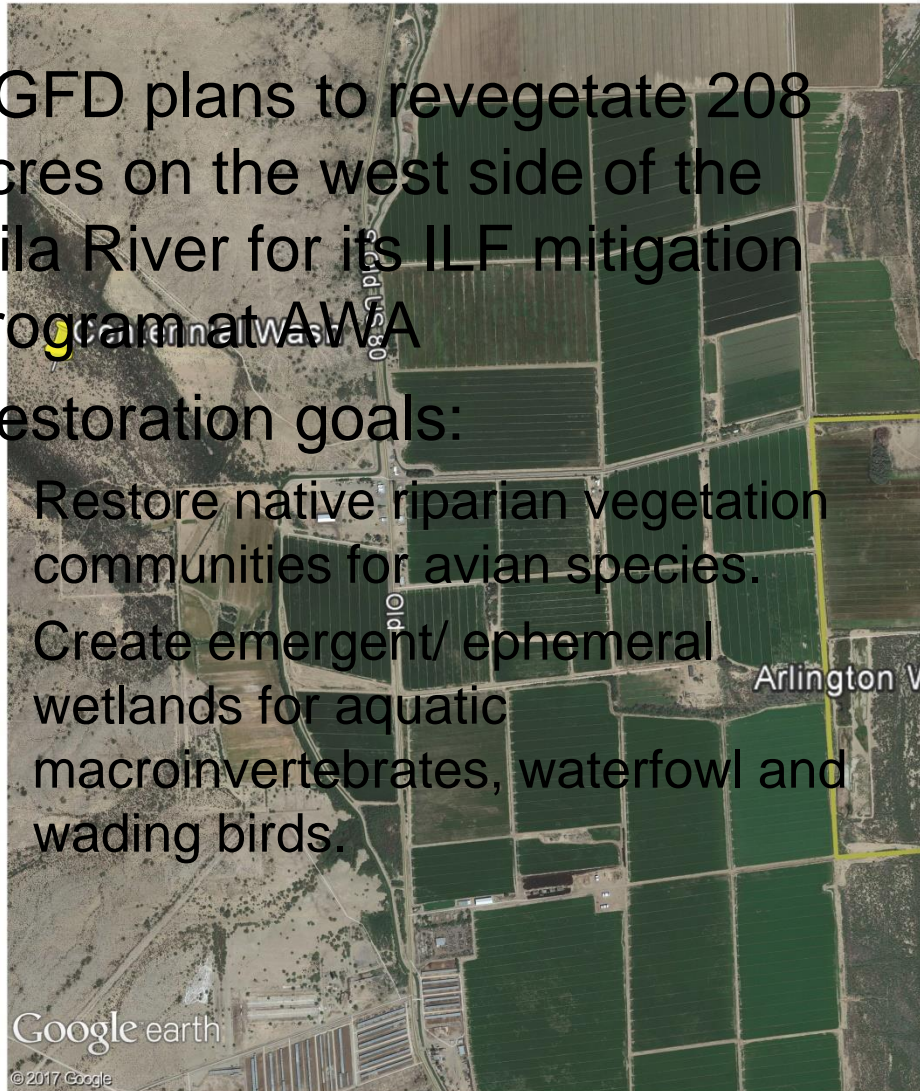
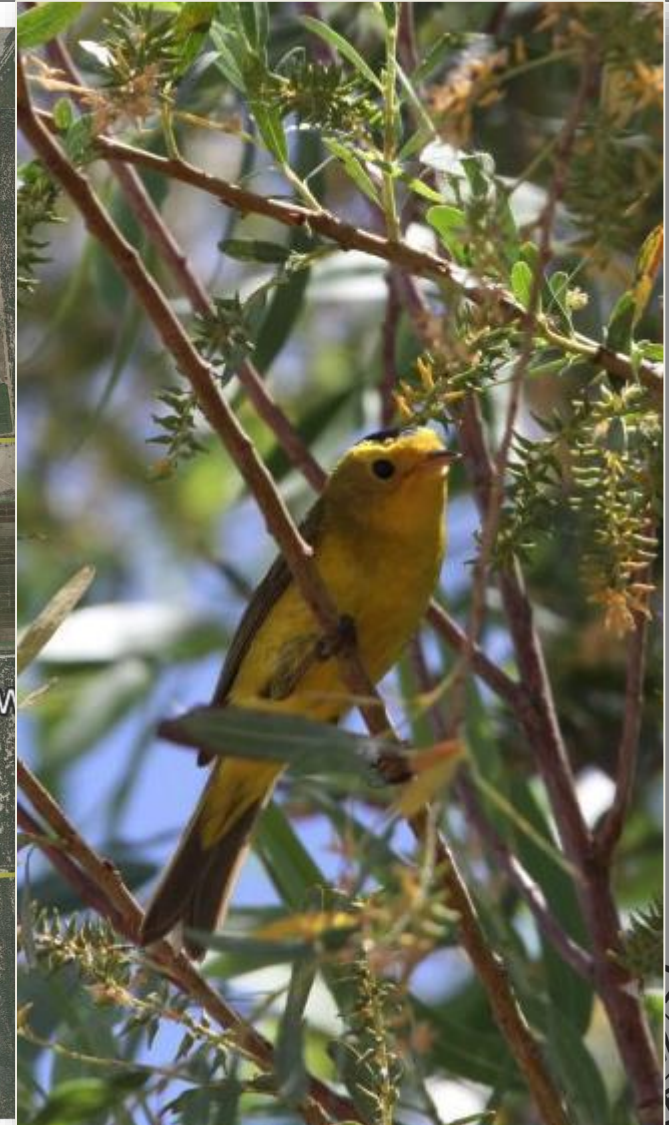
Emergent wetlands:
10 acres

Ephemeral wetlands:
Increased from 0 to
12 acres

Cottonwood/ willow:
Reduced from 69 to
21 acres

Mesquite bosque:
Increased from 98 to
148 acres

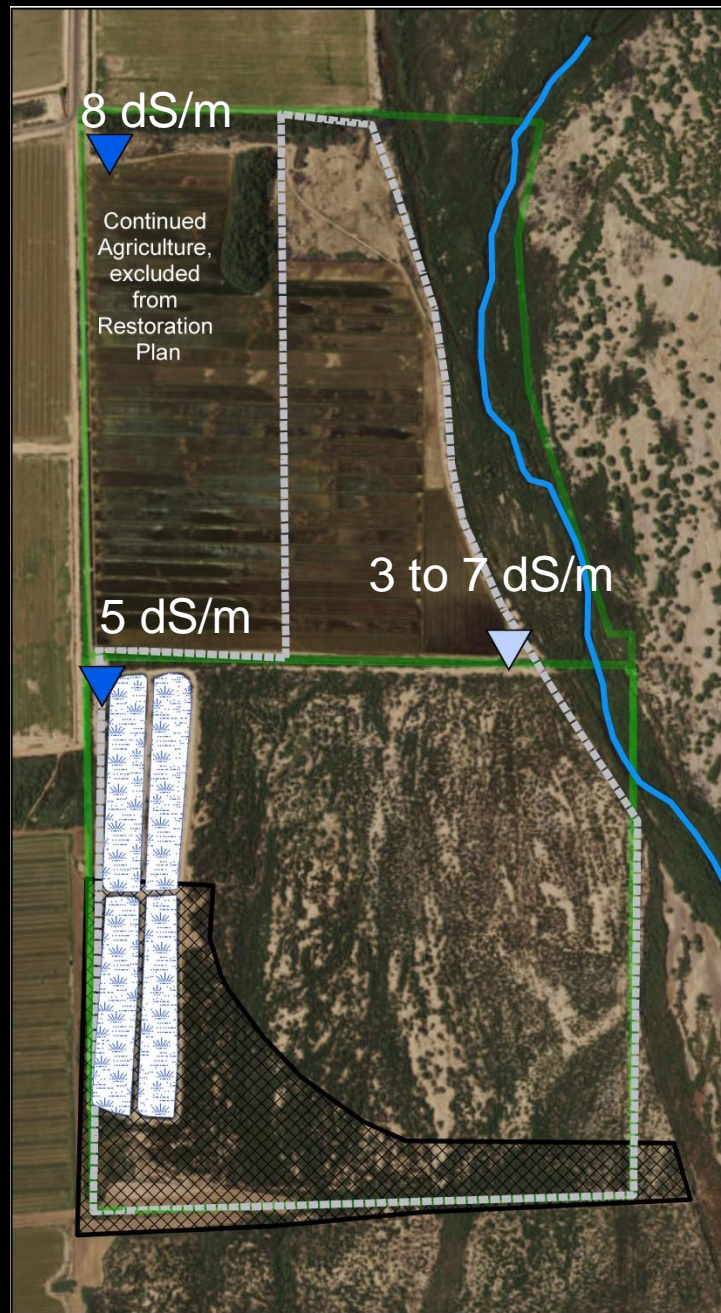
Arlington Wildlife Area Well Map

-   New Well
-   Existing wells
-   Gila River
-   Arlington Ponds
-   GSA site characterization area
-   Richardson parcel
-   Jagow parcel
-   Grading Area (proposed)
